Offset site number : EPBC 2011/6004

Report No.: #9, April 14, '24 - April 13, '25

Management Actions – EPBC 2011/6004

Year # 9 April 14, 2024 – April 13, 2025.

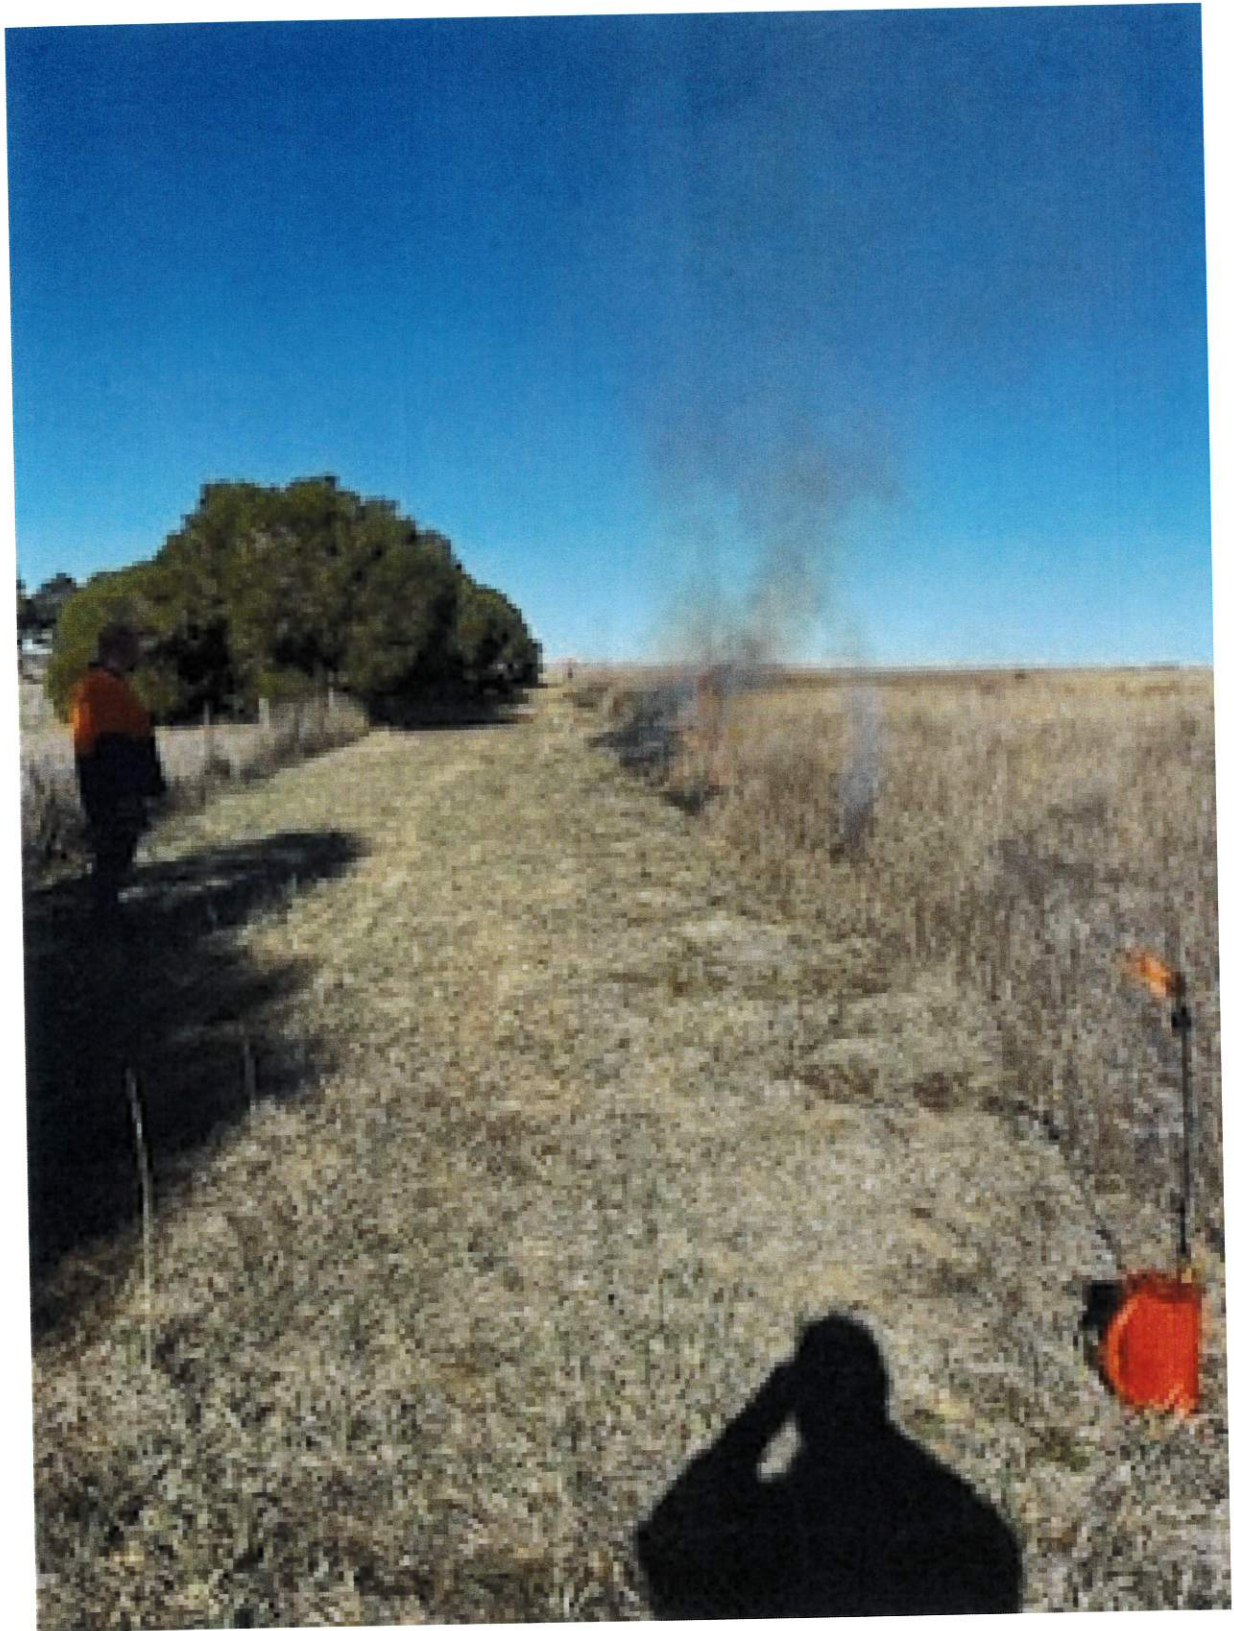
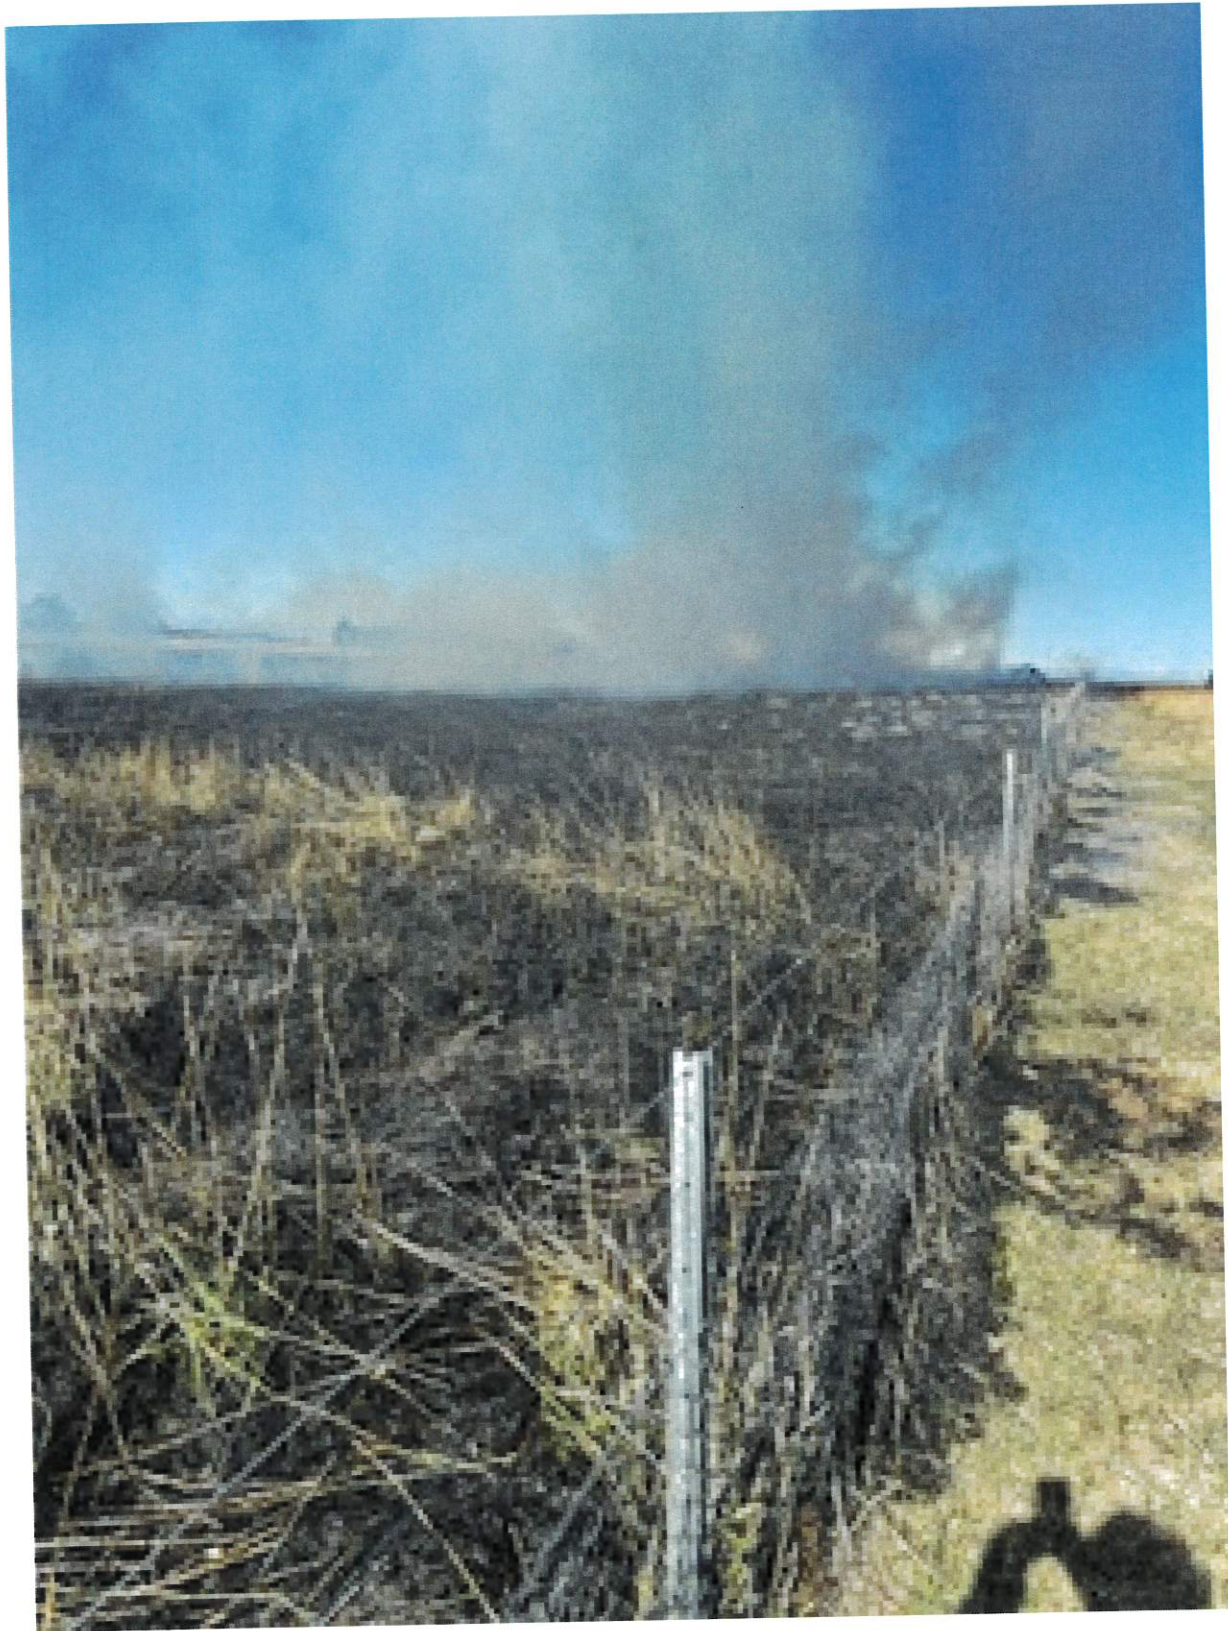
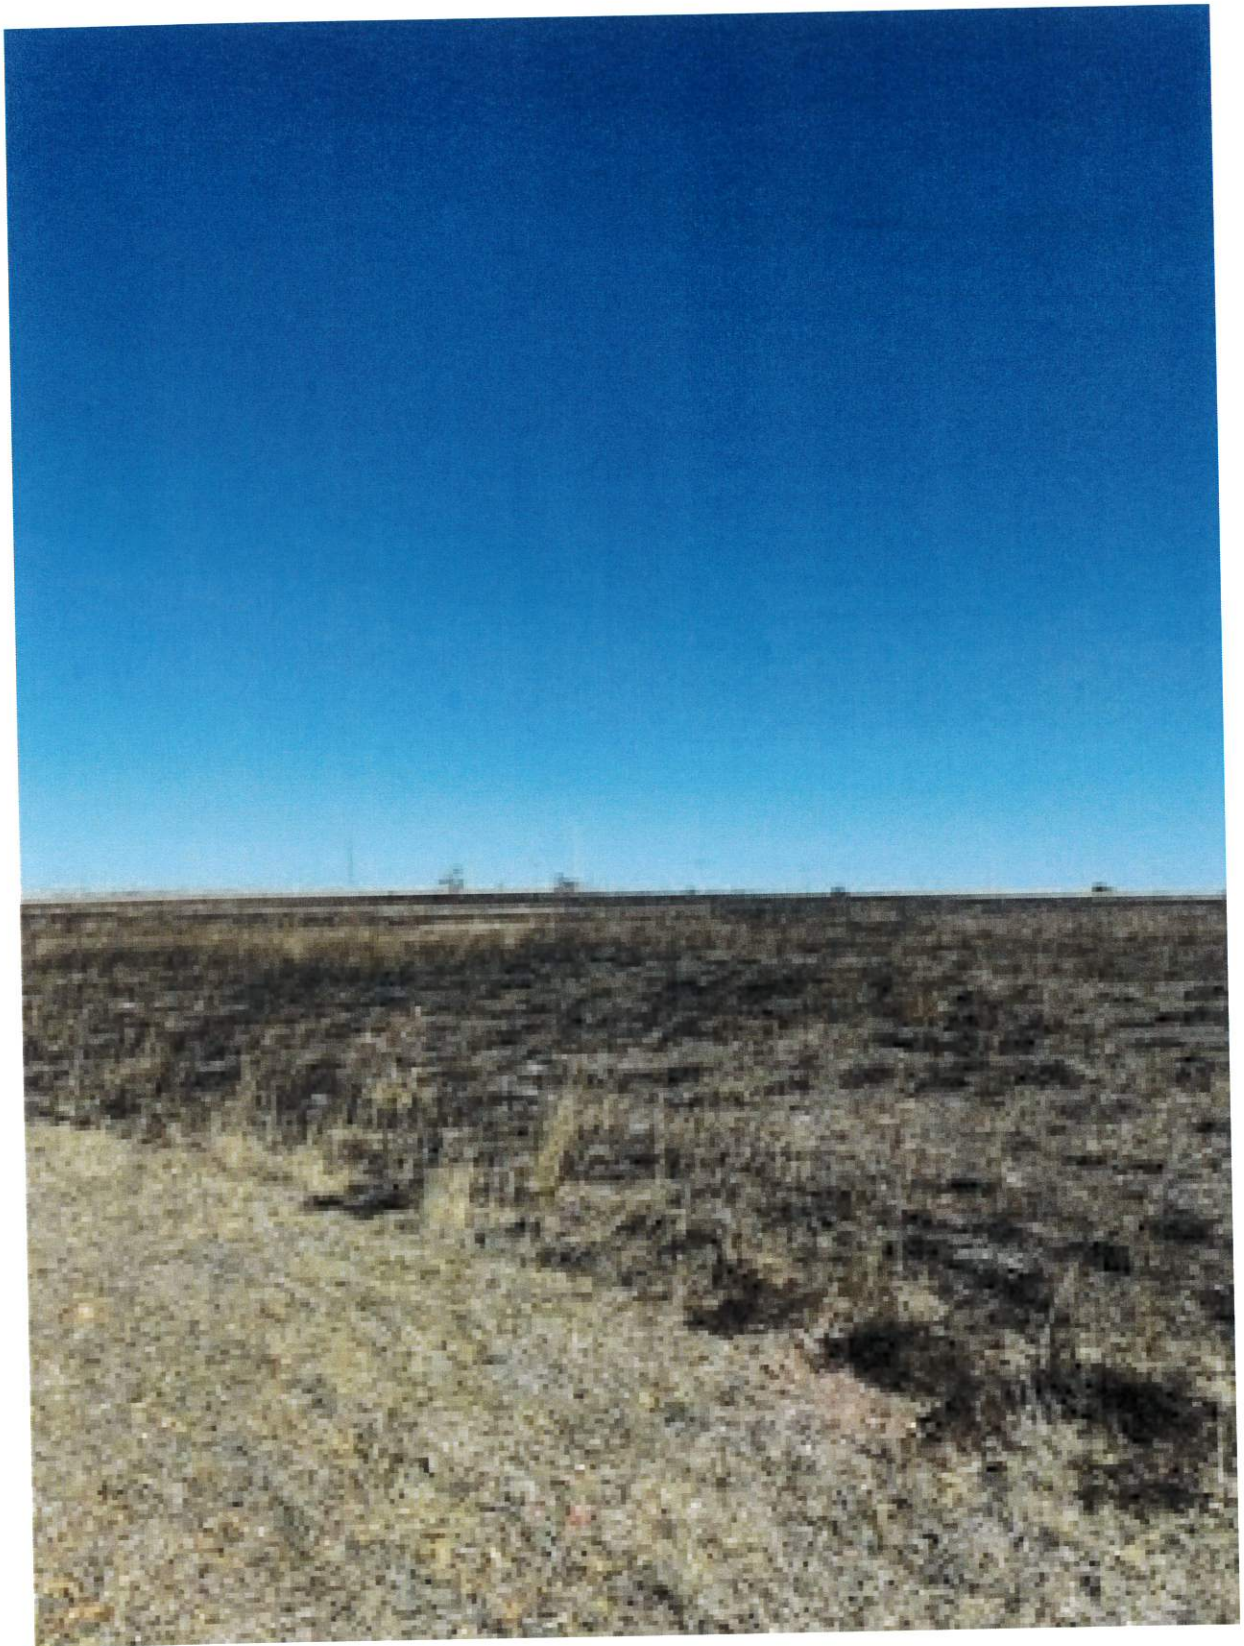
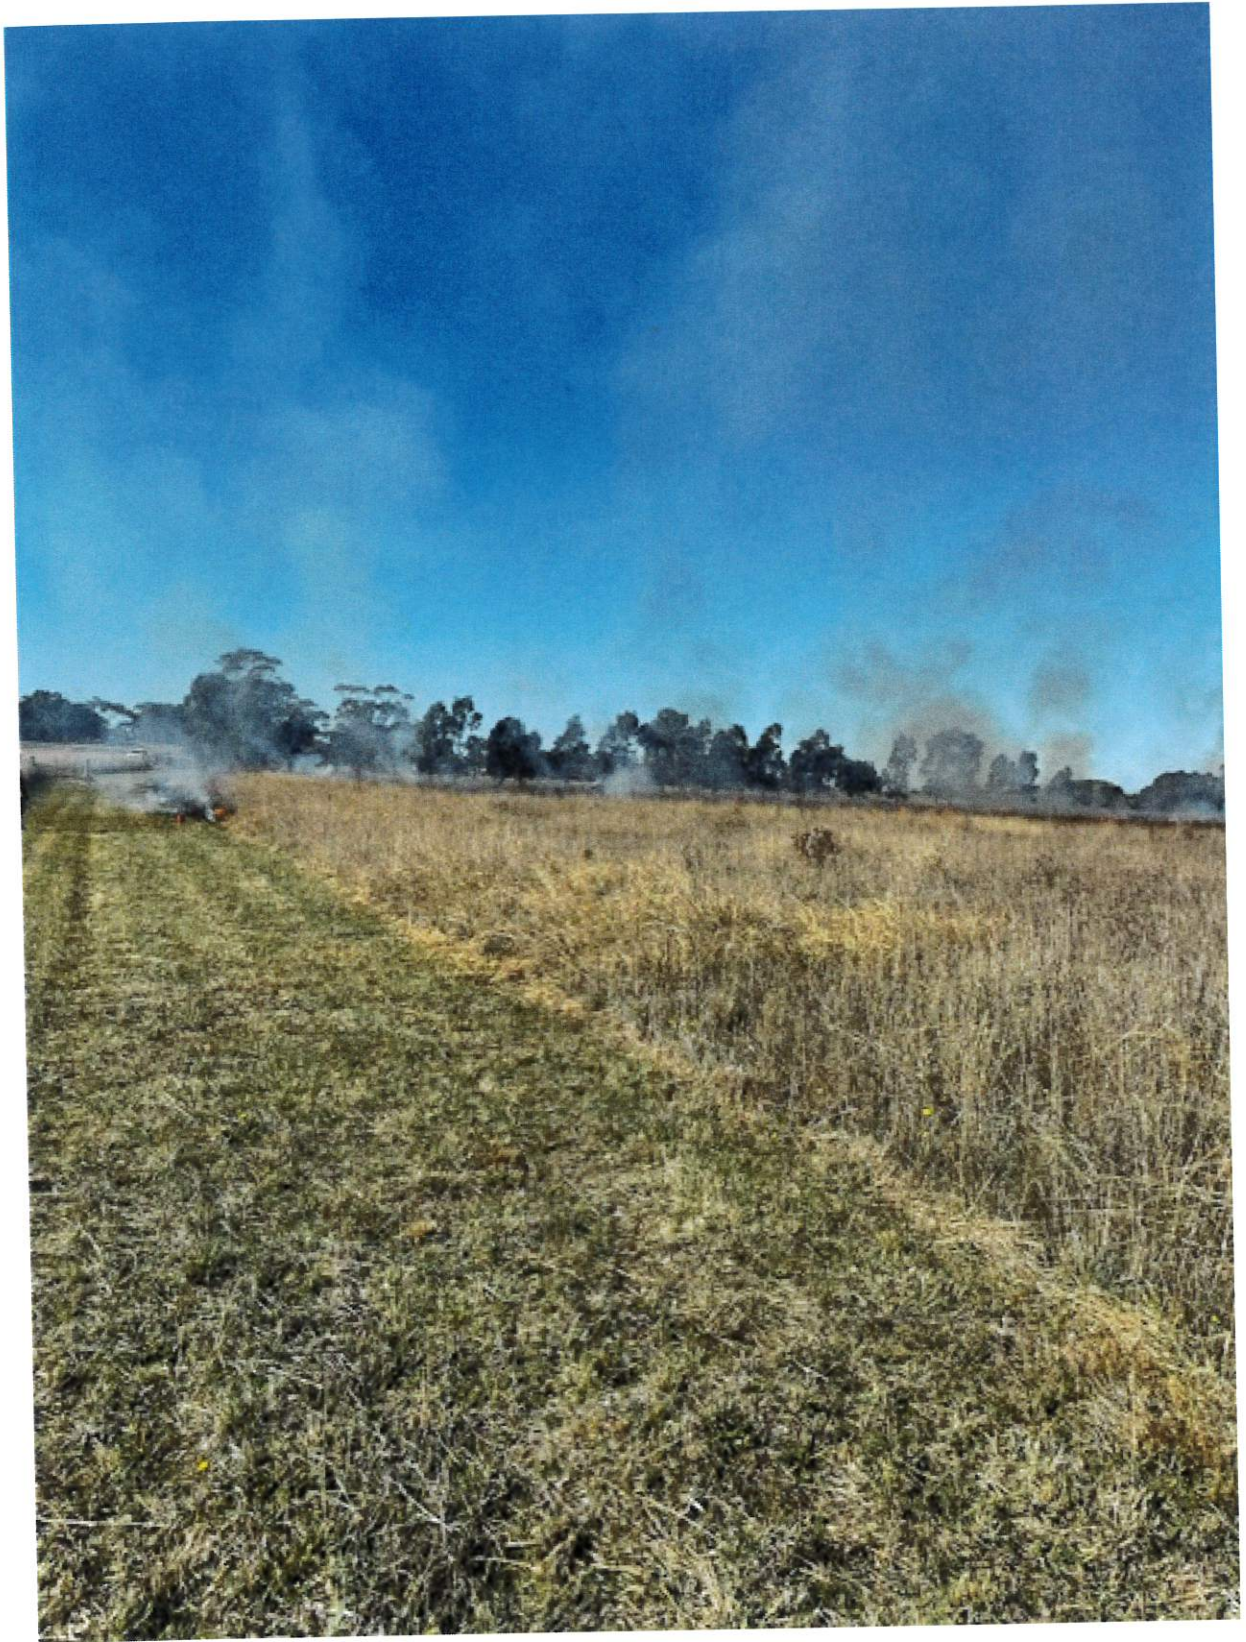
The Spiney Rice Flower community contained within Zone 20 of Area A was burnt on May 16, '24. The SRF's were not in flower, nor looking like they were close to flowering at the time of the 'cold burn' In previous weeks, as part of yr. 8 management actions, Small Farm Contracting (SFC) undertook slashing of firebreaks within the fenced off area, but outside of the offset zone. Weather for the day, was sunny with little to no wind, which made for a well-managed 'cold burn'. Images of the burn are attached at appendices 1-4.

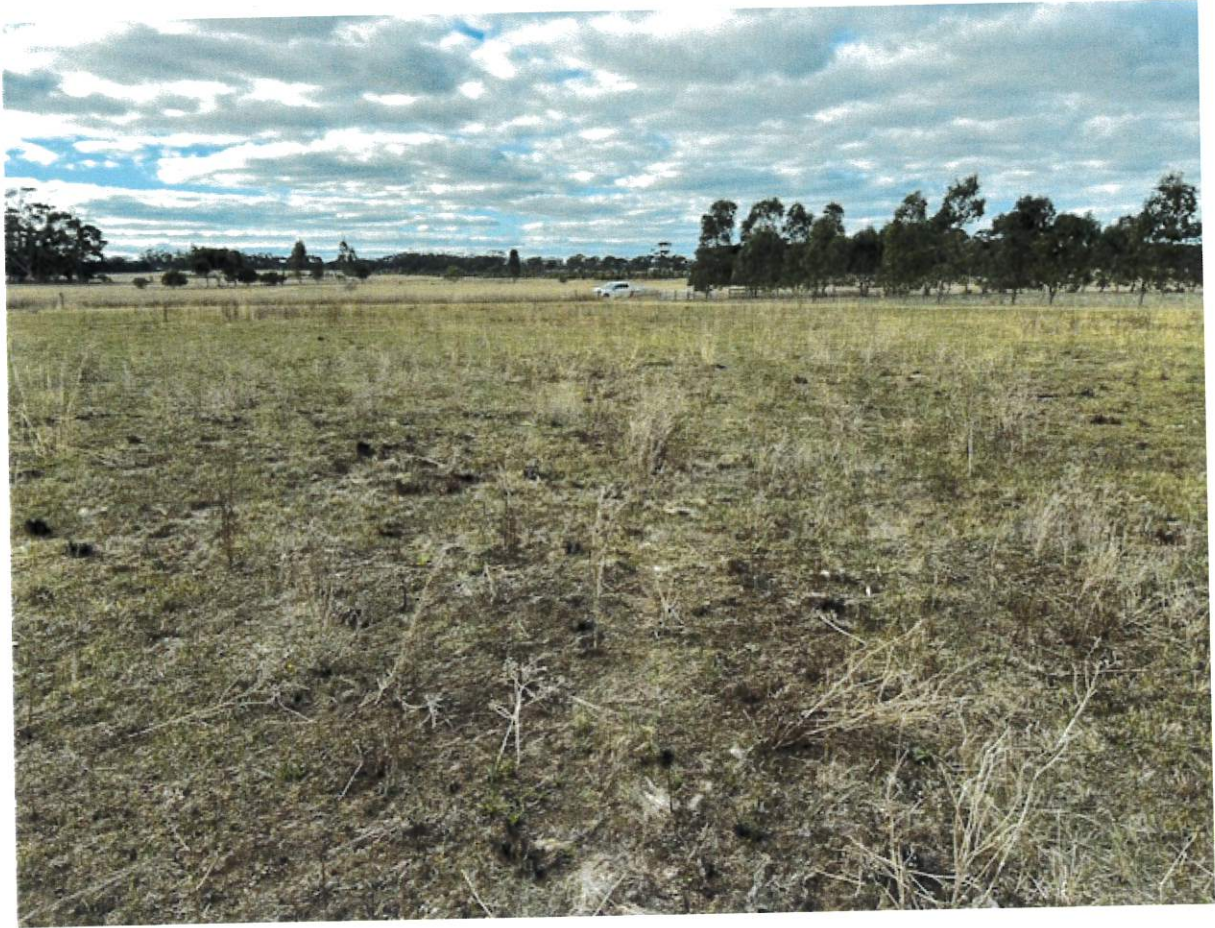
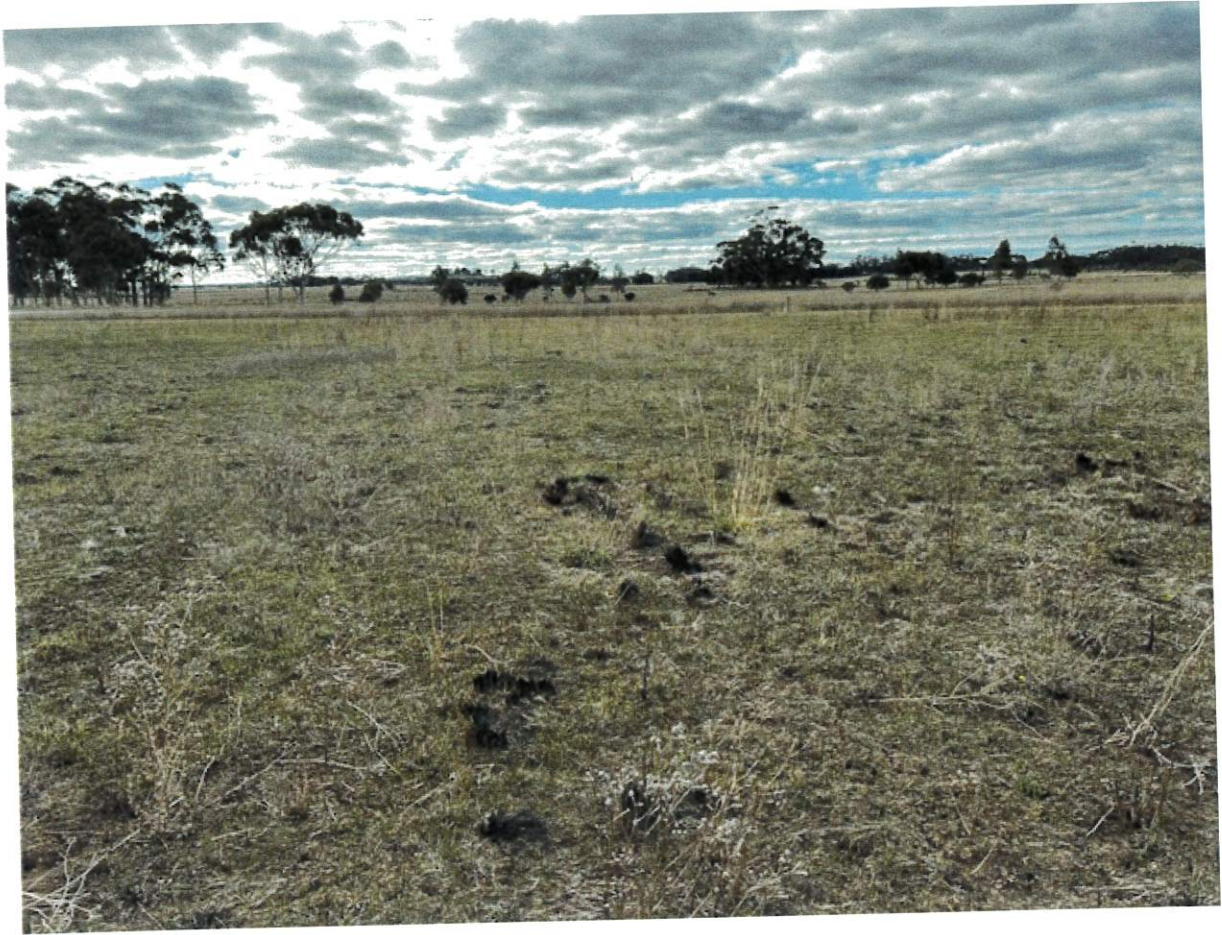
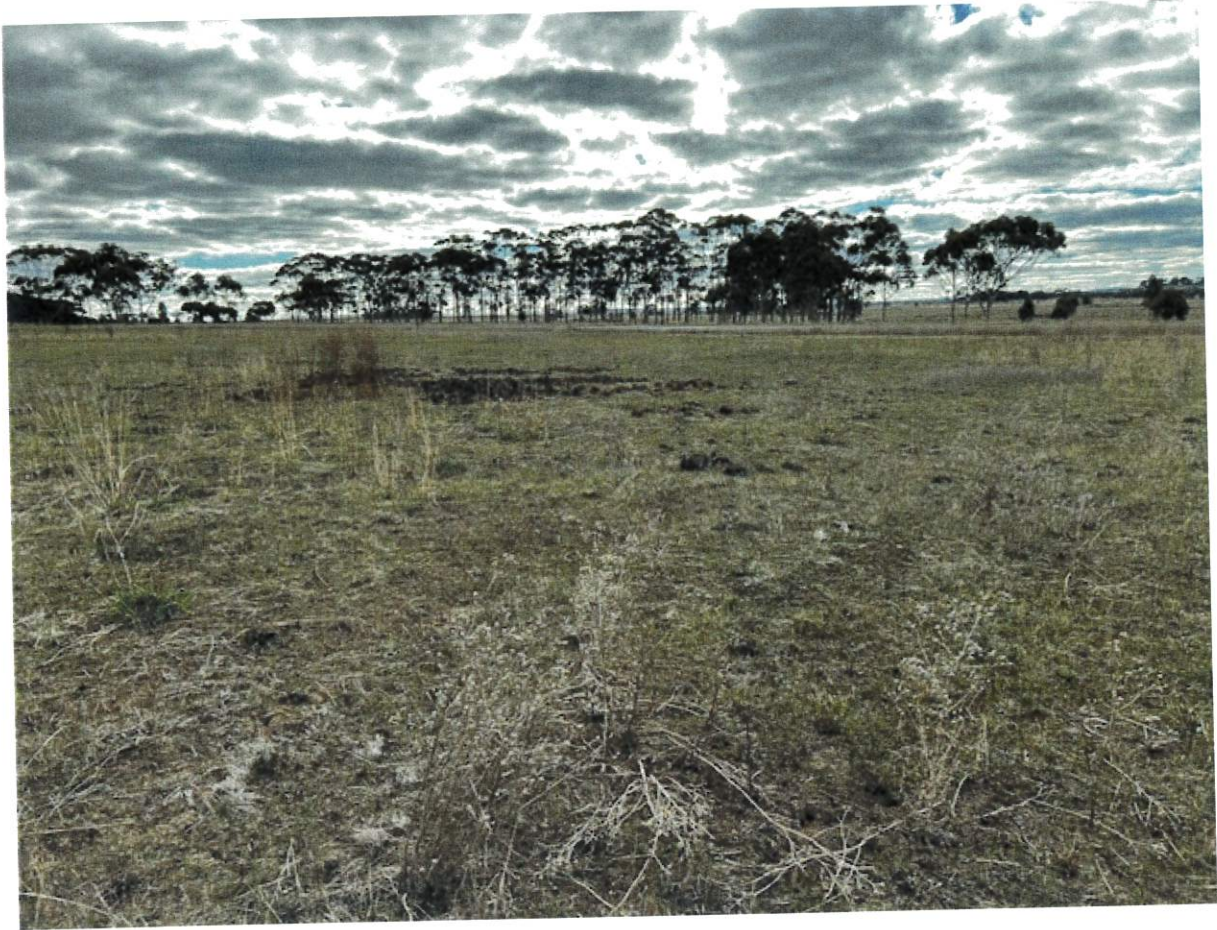
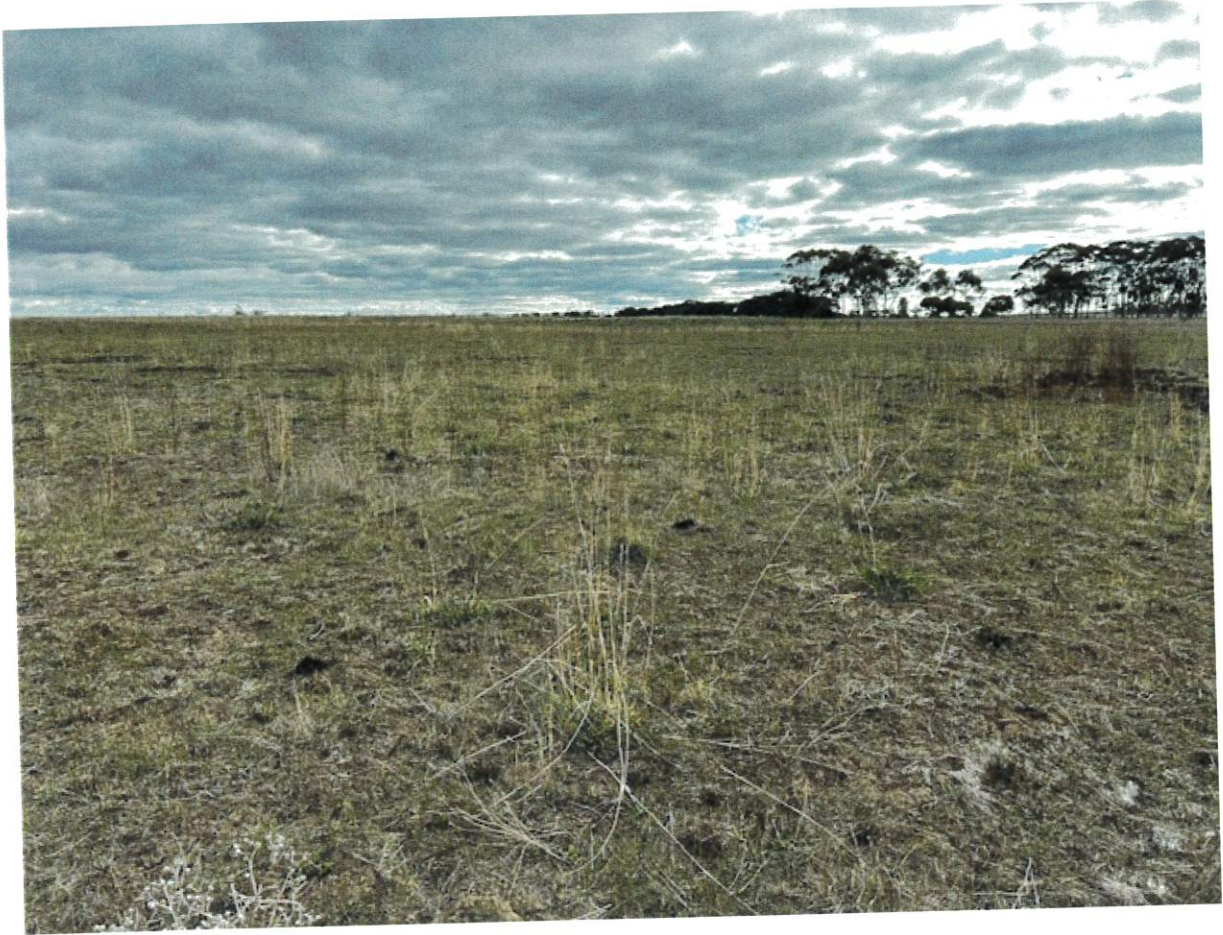
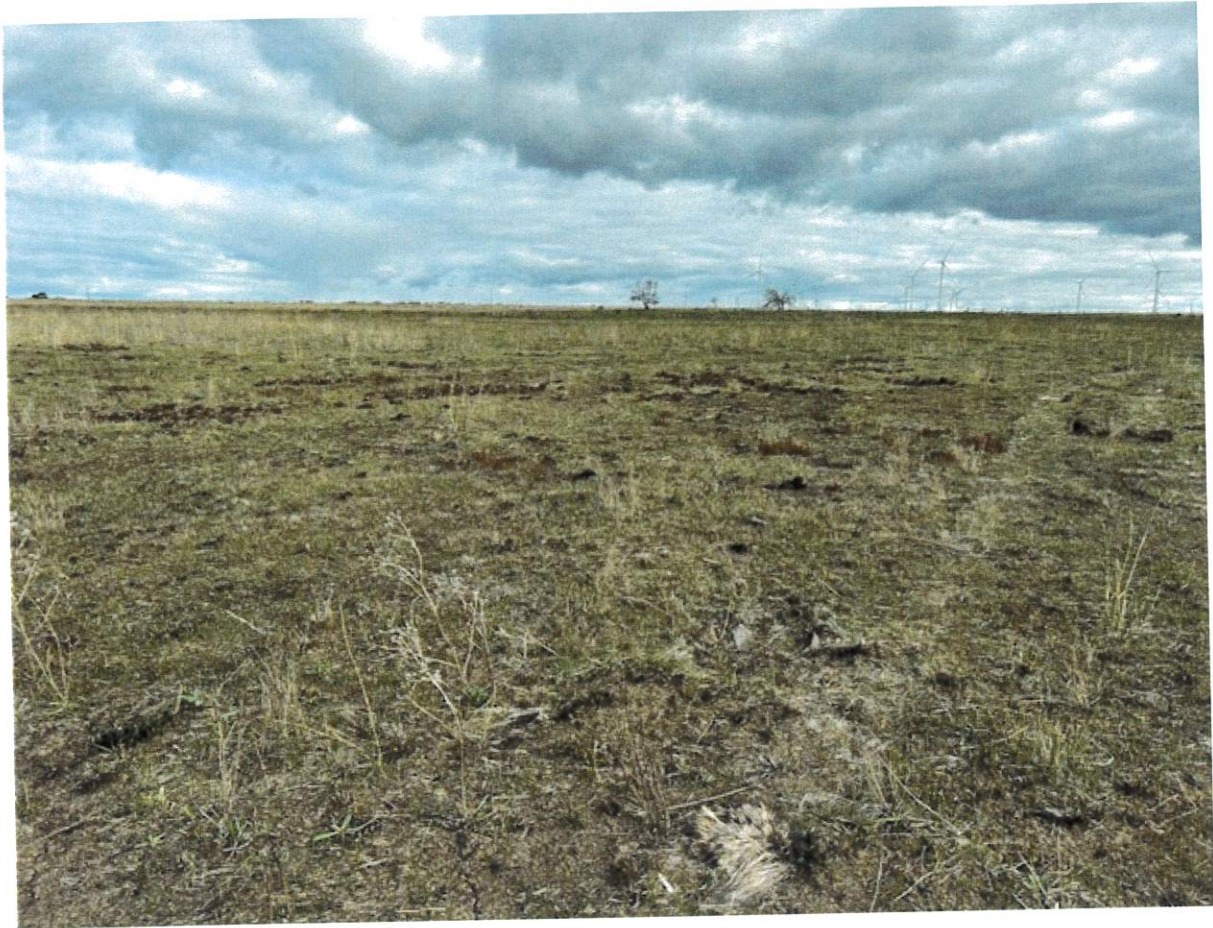
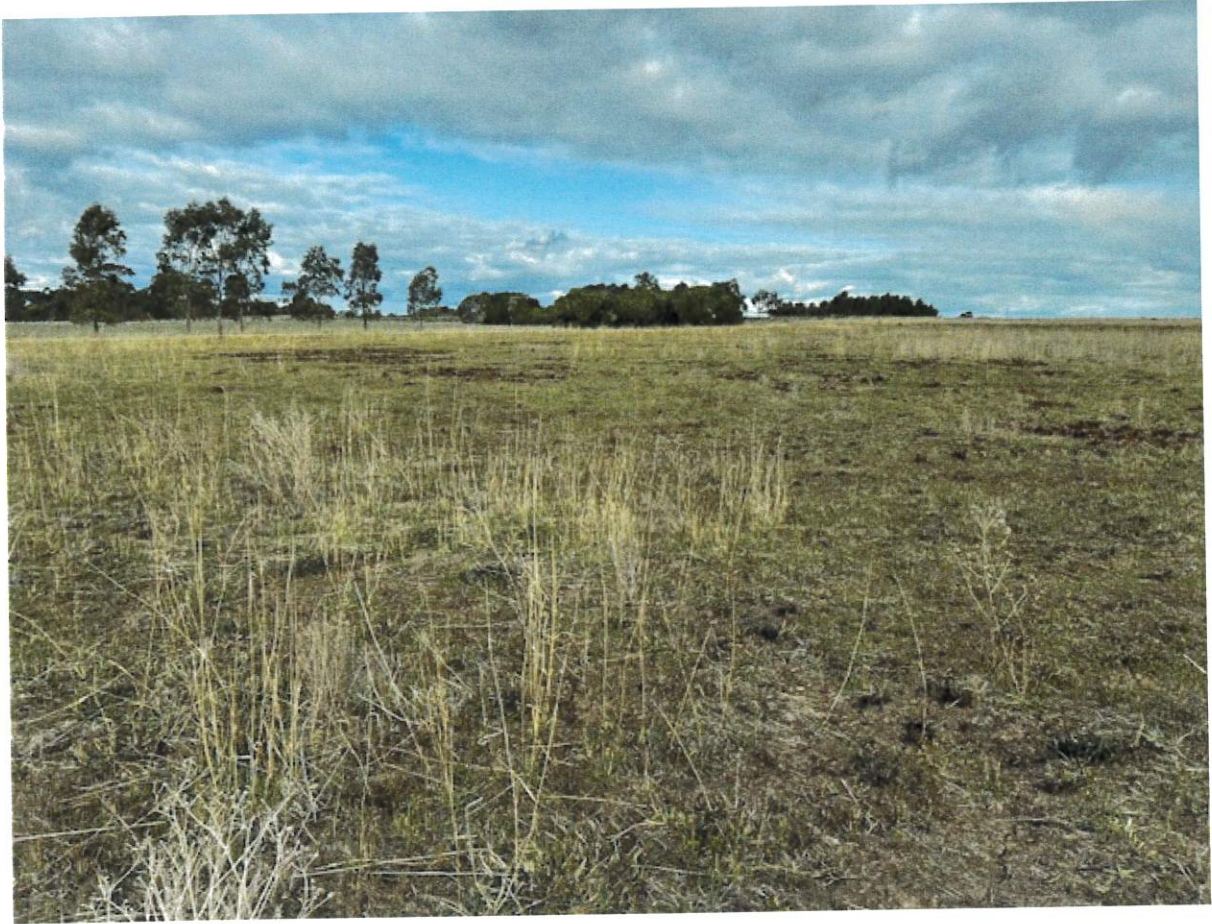
Attached at appendices 5-10 are images of Area A post 'cold burn', taken on a site visit by an MGP representative, on July 2, 2024.

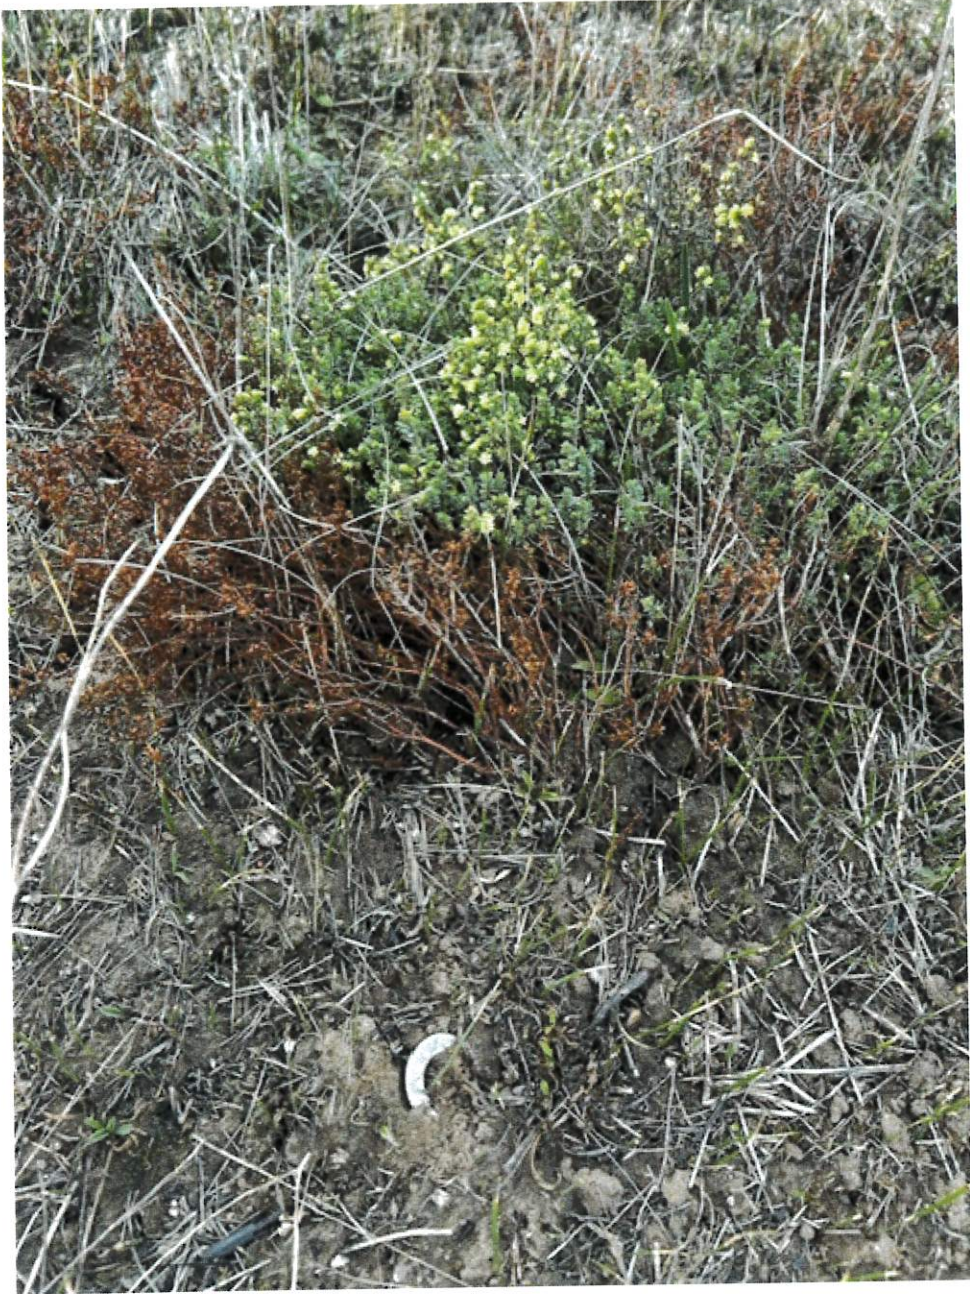
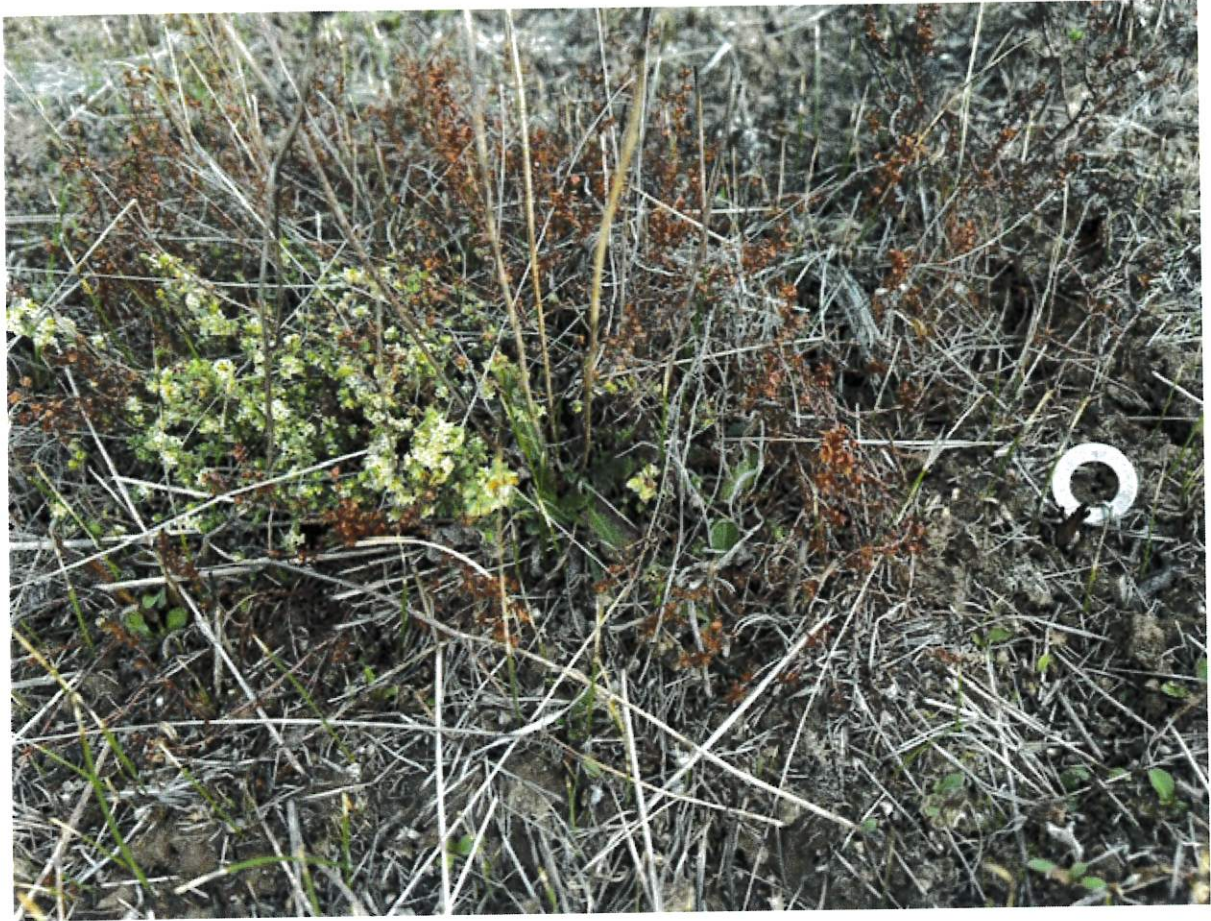
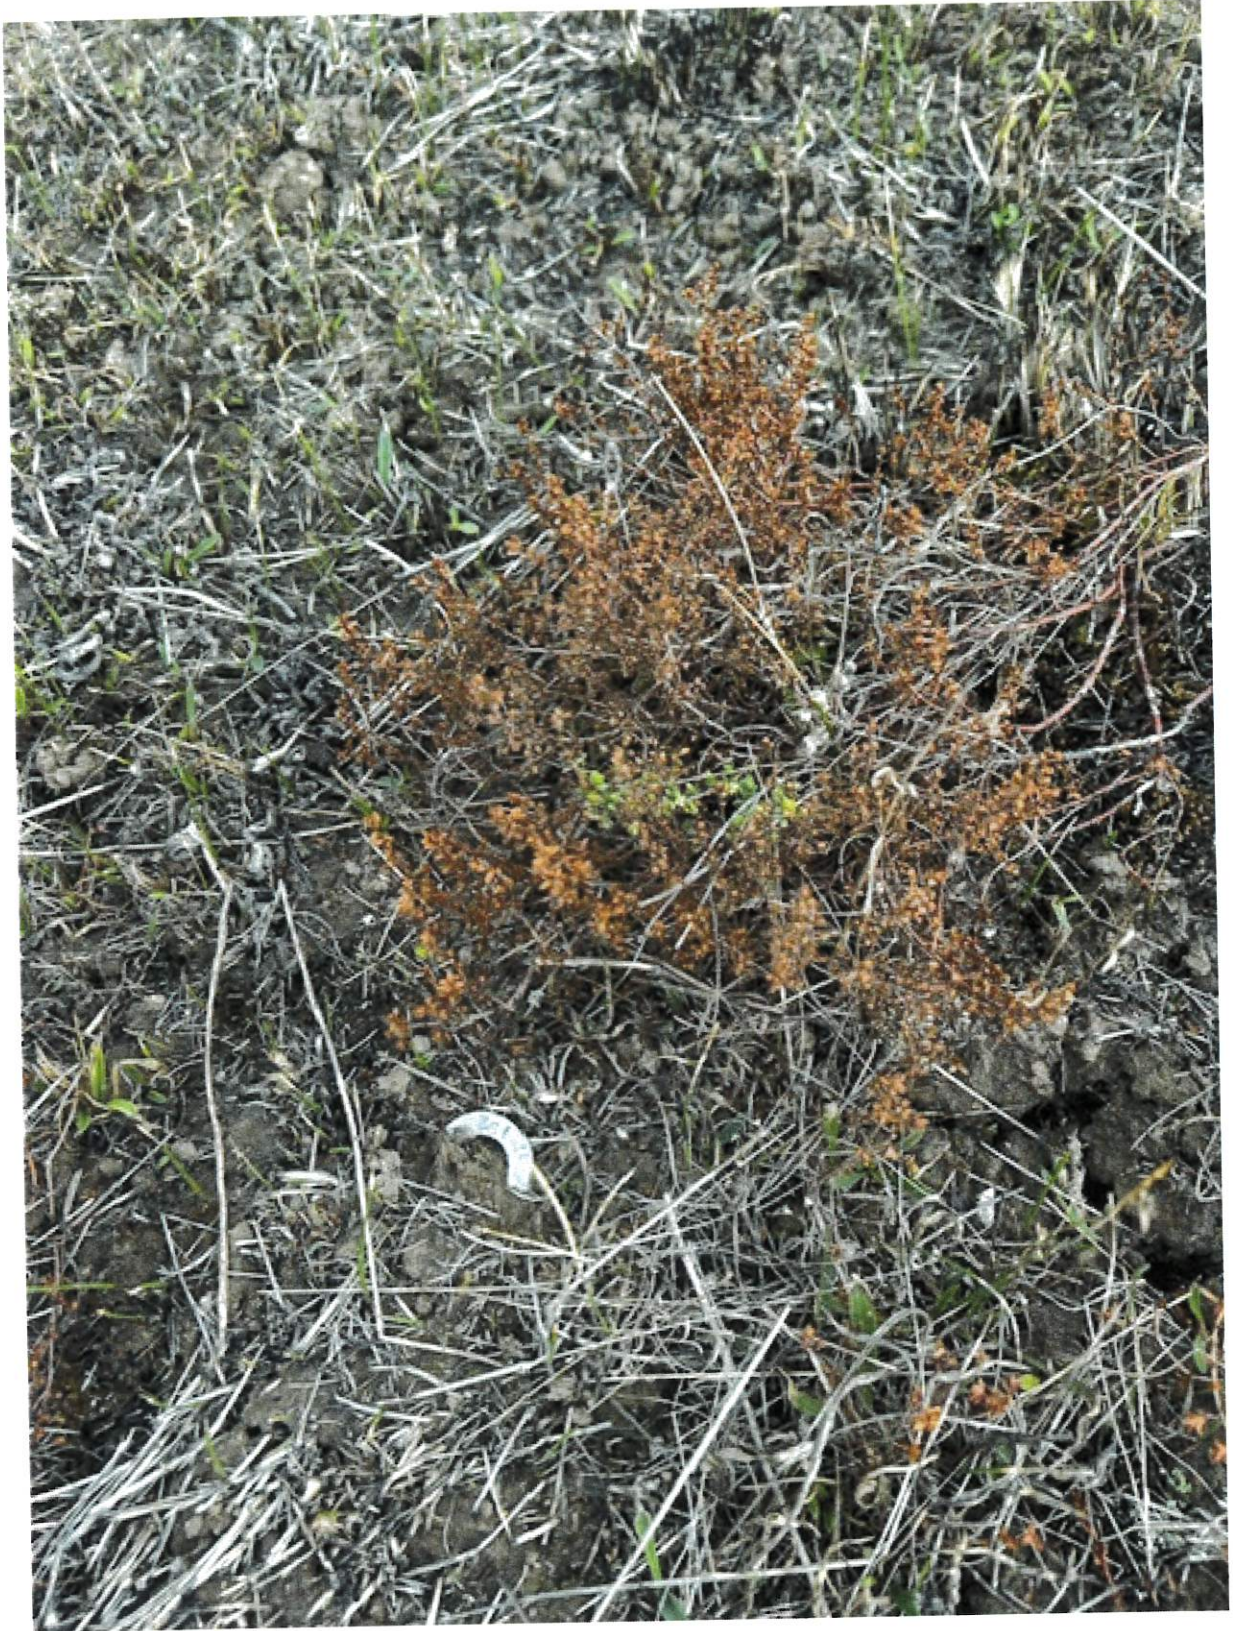
Images 11-13 depict the re-growth of SRF's post 'cold burn' also taken on July 2, 2024. Clearly visible are the numbered, stainless-steel washers staked adjacent to each plant within the community.
